**Application Note**

Vertical Streaks in Millisecond Exposures in Interline CCDs  
November 4, 2004

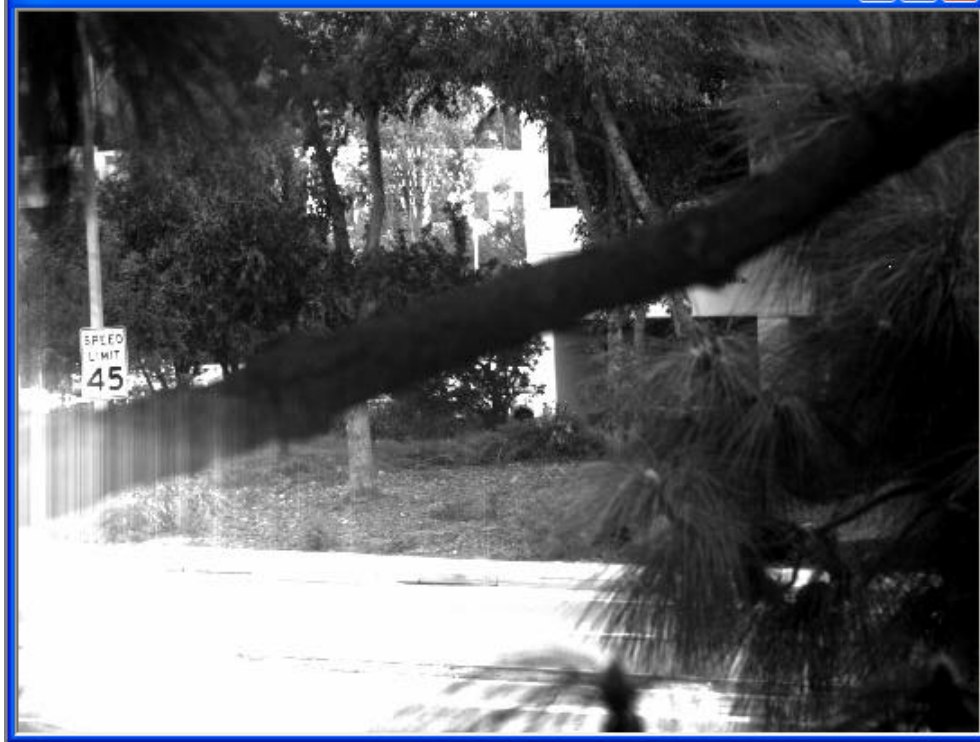
Cameras based on interline CCDs like the ST-2000, STL-11000 and STL-4020 show a vertical streak artifact in millisecond type exposures of bright objects as demonstrated in the image below:

*0.001 second exposure in ST-2000 in Low Res mode*

This artifact is a side effect of optimizing the antiblooming voltage on the interline CCDs ( $V_{sub}$ ) for long integration astronomical imaging. We have set the  $V_{sub}$  to a level that ensures a high full well capacity for long exposures but doing so causes this blooming in short exposures of very bright scenes.

Adjusting VR1 by  $\frac{1}{4}$  turn (90 degrees) counter-clockwise will raise  $V_{sub}$  to 10.5 volts and eliminate the vertical streaking. Unfortunately the 10.5 volt setting causes long integration images to saturate around 50,000 ADU rather than the desired 65,535 ADU as can be seen in the image below.

Our recommendation is you set the  $V_{sub}$  at 10.5 volts for millisecond exposures of bright scenes and then return  $V_{sub}$  to 7.2 volts for astronomical uses.
