SANTA BARBARA INSTRUMENT GROUP

> Application Note Frosting Problem on Some Recent USB Upgrades January 3, 2002

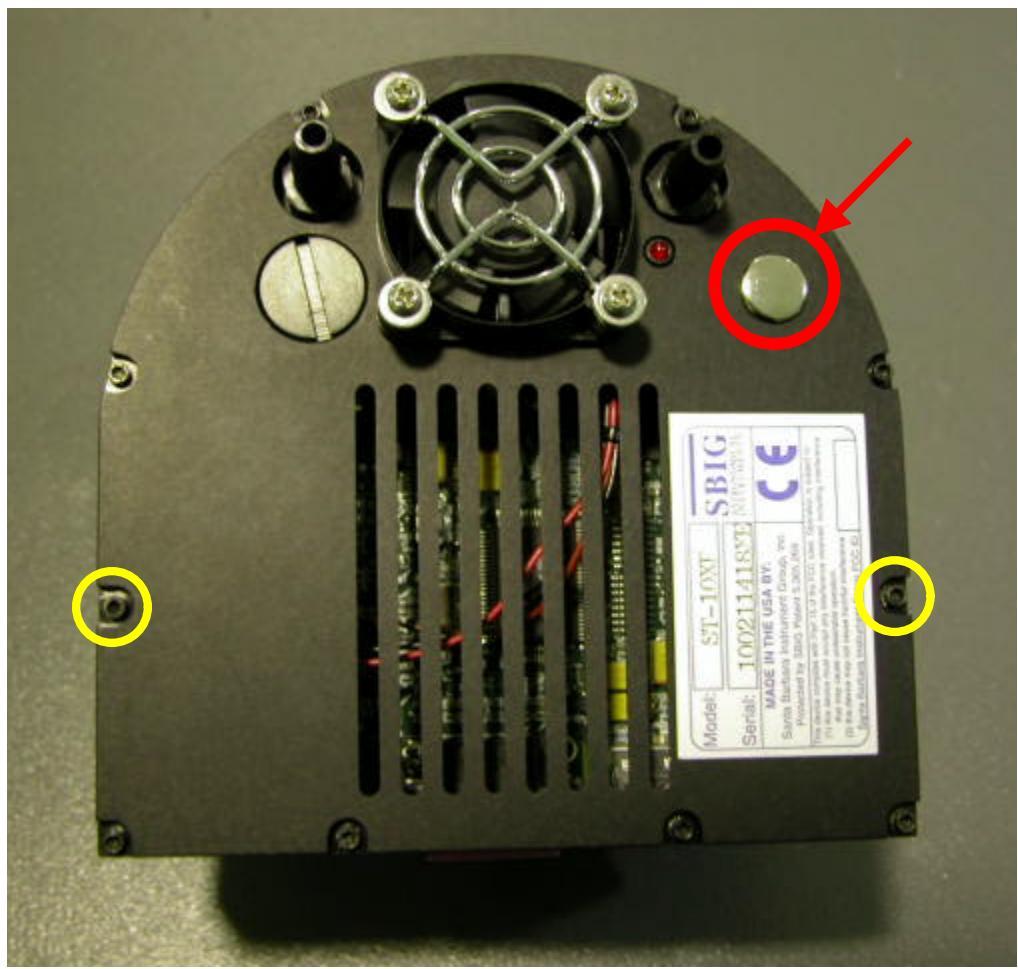
Figure 1 – View Port

Over the Christmas Holiday several users reported problems with their USB Camera Upgrades frosting the first or second time the camera was used. The problem was tracked down to a missing screw in the camera that allowed un-desiccated air from the rear of the camera to enter the front of the camera where the moisture in the air condensed then frosted on the CCD when it is cooled.

As shown in Figures 1 and 2 the missing screw is under the chrome coated plug on the upper right hand side of the camera when viewed from the back. You can inspect through the back cover by removing the chrome plug. Use your fingernails or a small screwdriver to pry out the plug. It's held in by friction. The screw hole is actually slightly above and to the left of the plug hole.

If you find that the hole is not plugged with a screw then you can easily plug it with a 4-40 x 3/16 or 4-40 x $\frac{1}{4}$ Pan Head Screw. Apply a small amount of Silicon RTV to the threads of the screw before screwing it into the hole from the back of the camera. You'll probably have to remove the back cover to do this and you'll notice two if the ten socket head cap screws that hold the back cover on are shorter than the other eight. They go in the position highlighted with Yellow in Figure 1.

At this point you should regenerate your desiccant plug as described in the manual. Essentially you swap desiccant plugs with the Dummy Plug, bake the live one at 400 F for 4 hours, re-swap plugs then let your camera sit for 4 hours prior to cooling.

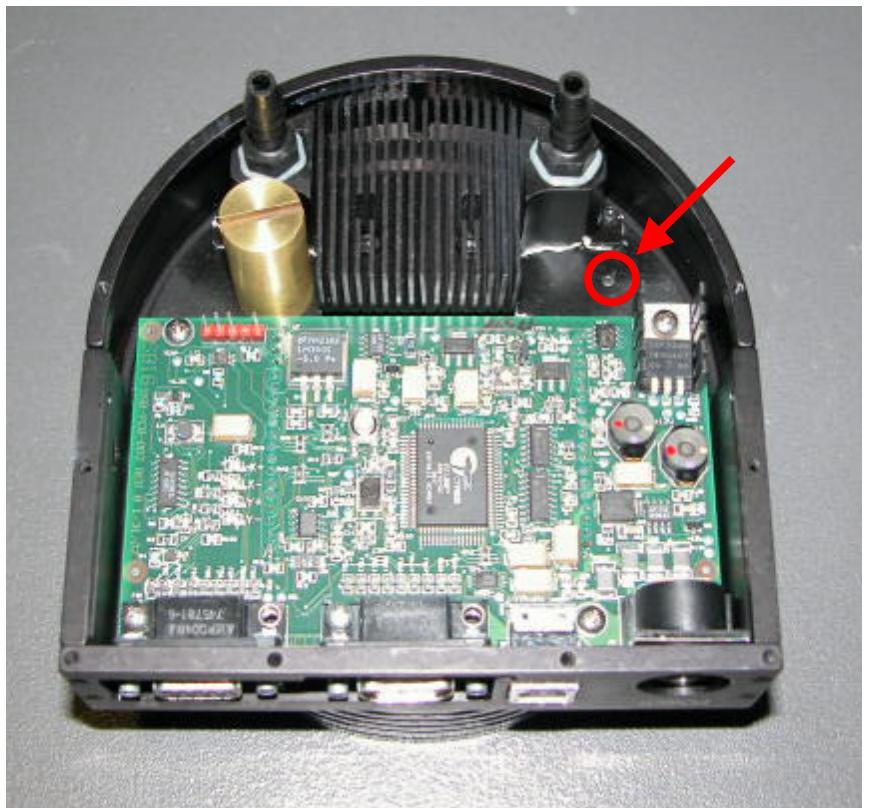
Figure 2 – Location of Missing Screw

The good news is that it's easy to diagnose and easy to fix without having to return the camera to SBIG. Figures 1 and 2 show the location of the hole, which is a 4-40 tapped hole on the upper-right corner of the camera.
